City of Baltimore Wet Smoke and Dyed	Page 1 of 2	
Sewershed: Gwynns Falls	Company: Savin	Date: 4/21/2009
Test to be performed: Smoke Dyed Water X	Ground Condition: Dry ☑ Damp ☐ Wet ☐	Supervisor: <u>JAW</u>
Manhole_ID: S05KK1018MH	Test ID: <u>D1032-034020</u>	Notification Made: NA (Residents, Fire, 311)

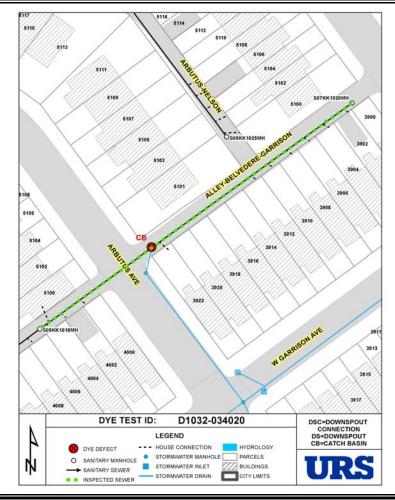
Field Sketch: Show all manholes with Numbers, Blower Placement Locations, Sandbag or Isolation Locations, Street Names, Building Addresses and Locations, Defect Locations and Photo Numbers.

Defect Loc	Obs_ClockFrom	Obs_ClockTo	Observation	Obs_Remarks
0			Water Level	
0			Manhole	S05KK1018MH
0			Start of Survey	
29.39999962			Joint Offset Medium	
37.29999924	02		Tap Factory Defective	JOM
37.29999924	02		Infil Runner	JOINT IN TAP 1 GPM
40.5			Joint Offset Medium	
101.0999985			Dye Test Visible	@ IR, 0.5gpm
103.9000015	01		Tap Break-in Intruding	
104.3000031			Joint Offset Medium	
107.3000031			Dye Test Visible	@ IG, 1.25gpm
